Squamish Training Berm Realignment - Wave Impact Assessment

Squamish River Watershed Society

Final Report

26 | 02 | 2020

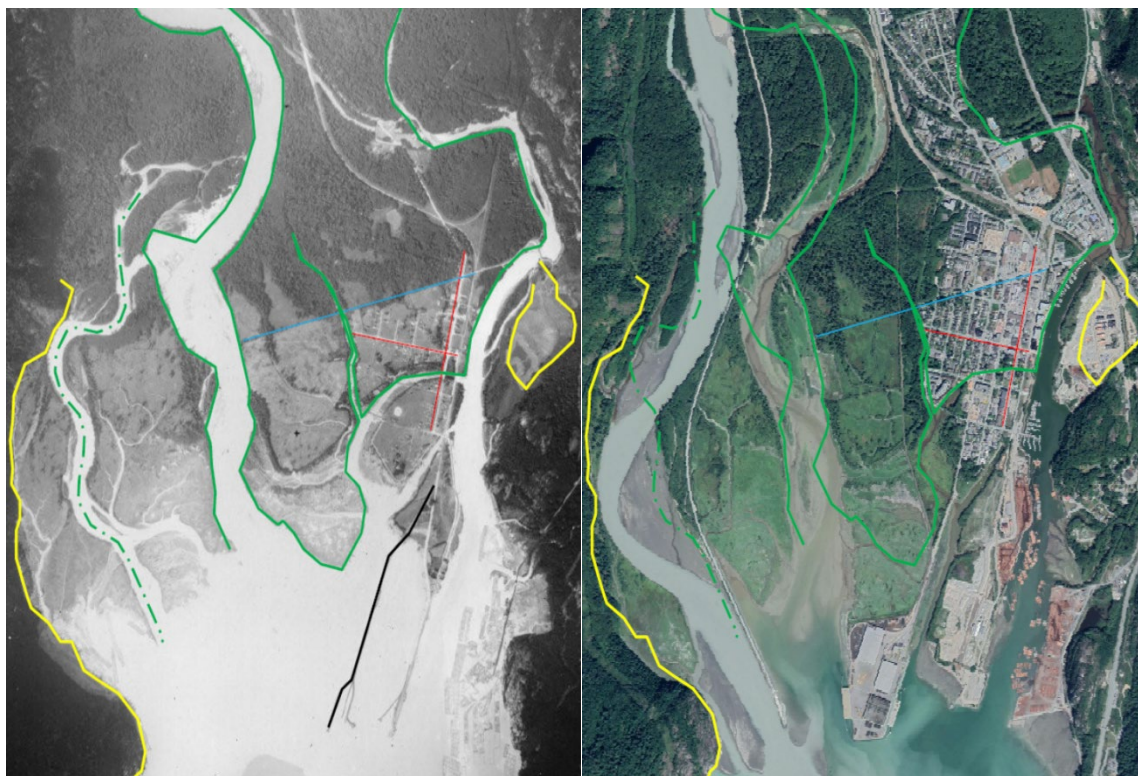
The Squamish River delta shows major change over time, likely due to the construction of the training berm in the 1970s (Figure 2). The river currently flows through its west branch. The thalweg of this branch migrated toward the west over time. The east part of the river in the Central Channel is currently shallower as sedimentation played an important role in the river morphology over the years. Figure 2 shows an approximate comparison of the river alignment between 1930 and 2019.

Figure 2 River alignment comparison, 1930 (left) and 2019 (right)

Historical air photographs suggests that the main channel of the Squamish River will likely migrate eastwards at the south tip of the central Island (Figure 2) once the training berm is removed. Therefore, the bathymetry has been modified to represent the assumed new riverbed. The west bank of the existing river, from elevations higher than -1 m CD remained unchanged. East of the riverbed toward Squamish District depths were also increased to allow the interpolation of a gentle slope up to the eastern side of the central estuary. The bathymetry along the sections of the berm removal were changed to the average depths from east and west side of the berm. The proposed Scenario 1 bathymetry is presented in Figure 6.
