Squamish Estuary Salmon Habitat Recovery Project
C1-PAC-02-A2 (17-HPAC-01341-A2)
2018/2019 – YEAR 2
FINAL REPORT

Prepared for:
Coastal Restoration Fund

Prepared by:
Edith Tobe, RPBio, Executive Director
Squamish River Watershed Society
Box 1791, Squamish, BC, V8B 0B3

May 24, 2019

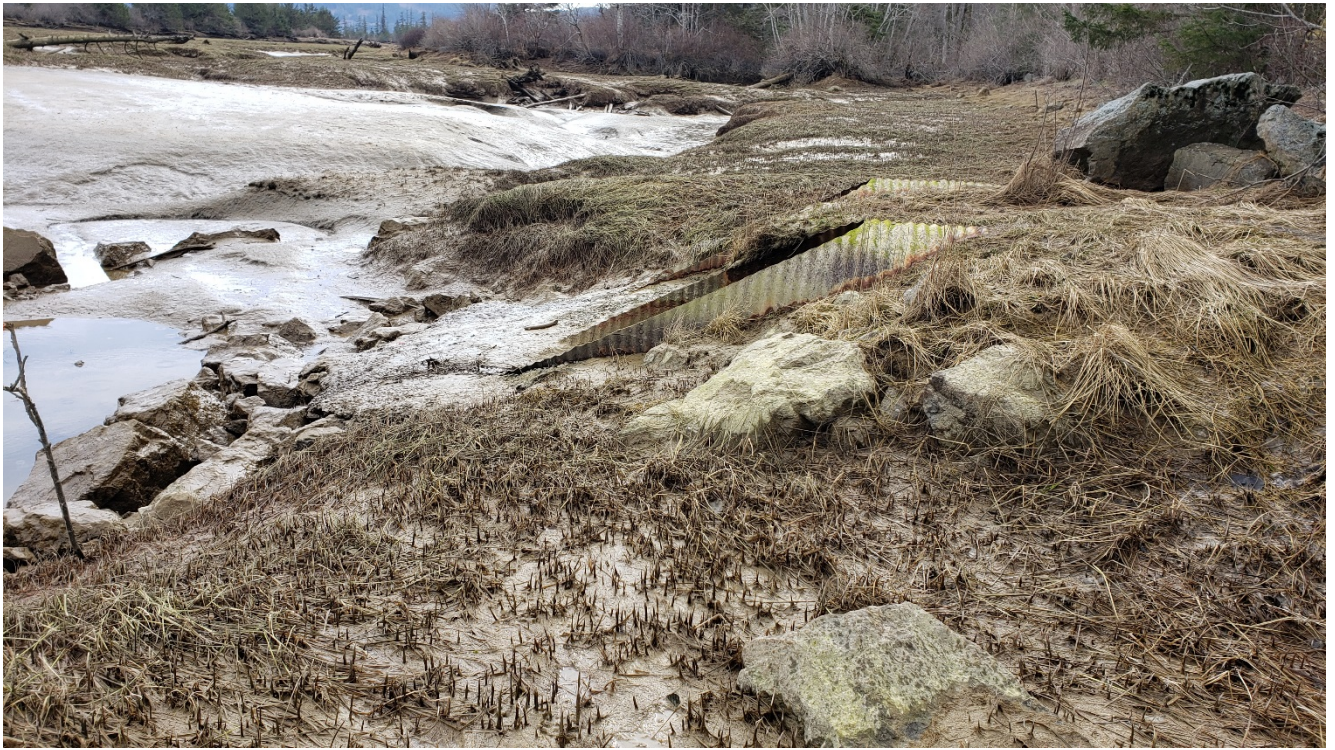
Photo 1. Original twin CSP (on estuary side) facing south

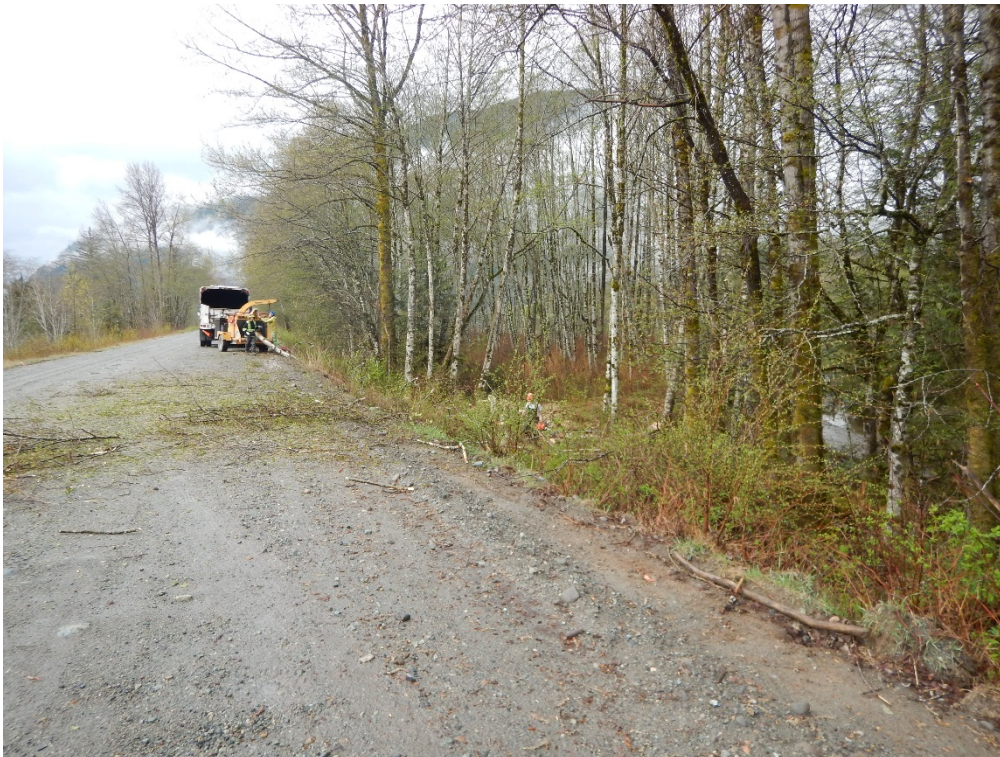
Photo 2. Clearing vegetation in preparation of site excavation

The site preparation included the removal of the vegetation in March prior to any bird nesting activity and a report was submitted for approval to the provincial government in advance of any tree clearing (Memo – CERP Tree Survey, March 2019). The access to the road was closed off to the public and a coffer dam on the river side of the culvert was installed to act as a plug. Due to the location of the site being within tidal estuary where there is an average of 4.6m tidal exchanges daily, working in the “dry” was not an option and the estuary side of the work site remained open to tidal flow. The site was excavated over a 4-day period and the old twin 1.2m CSP culverts were removed (and discarded). The bedding for the site was prepared during low-tide periods and over the course of two days the culvert and headwalls were installed. The channels leading from the river and into the estuary on either side of the headwalls were shored up with a minimum of 1.5m of large armour rock to be level with the invert of the headwall/culvert. Additional armour and riprap were extended along the river intake channel to prevent scour.

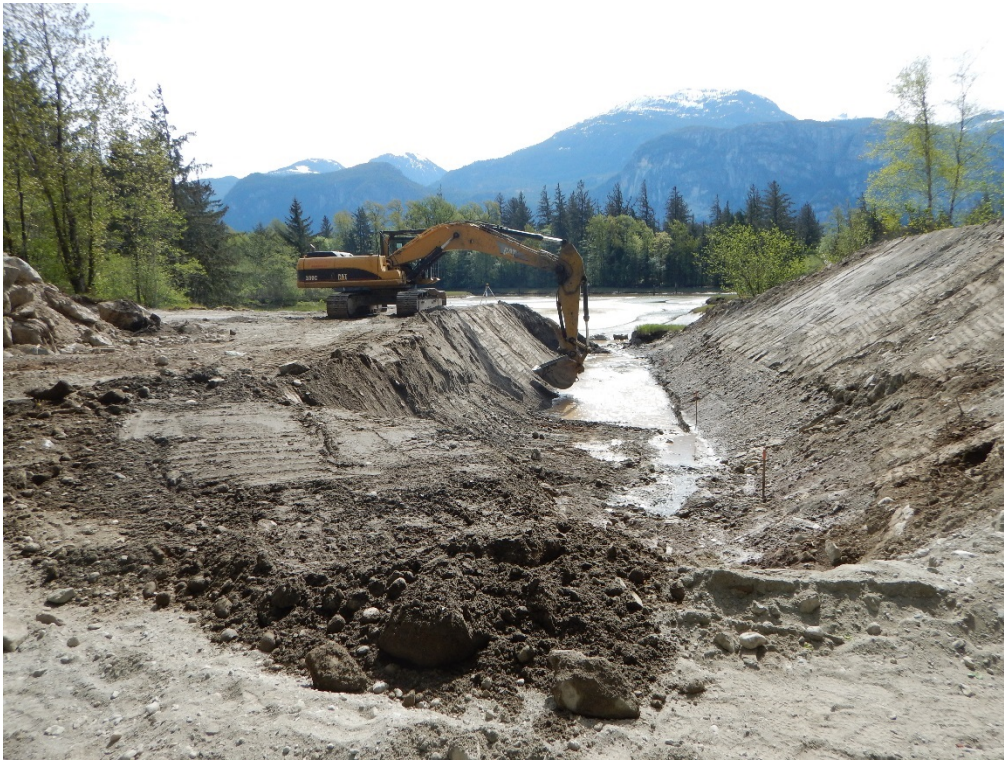
Photo 3. Preparing the opening

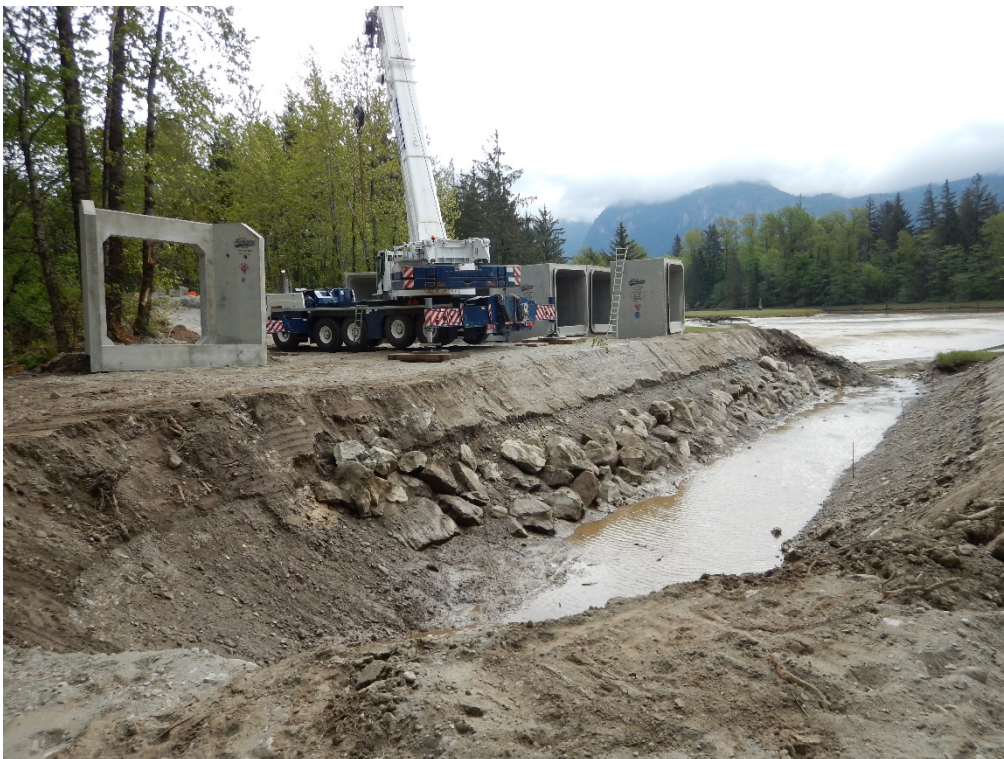
Photo 4. Crane set up to commence culvert install the following day during low tide

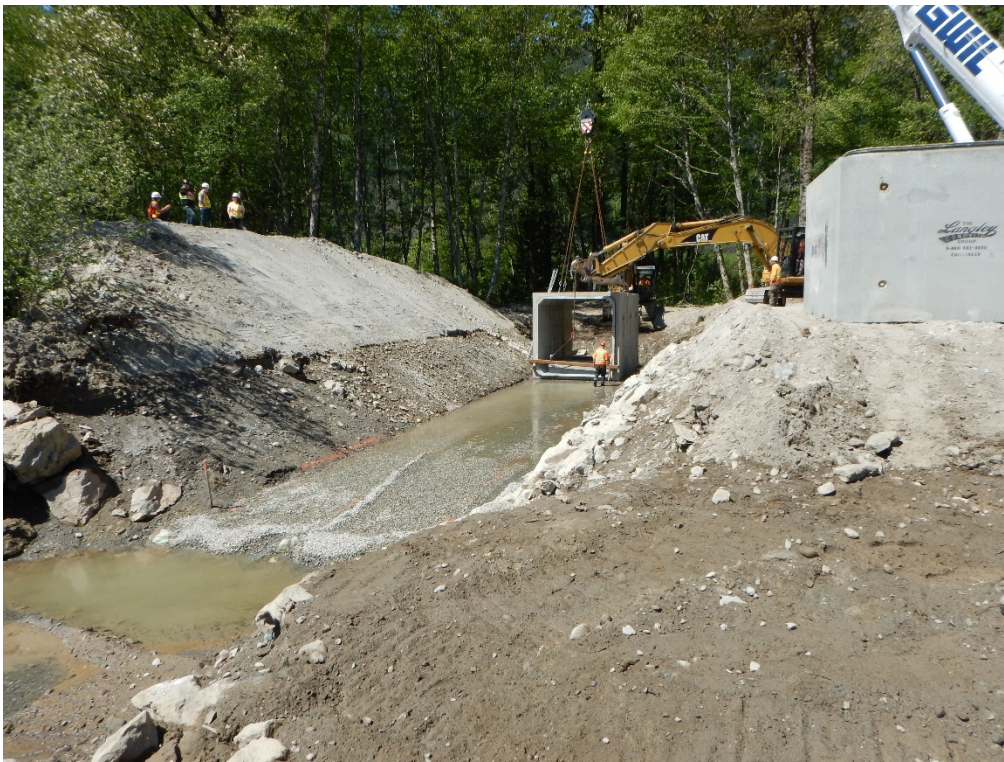
Photo 5. Channel ready for culvert installation

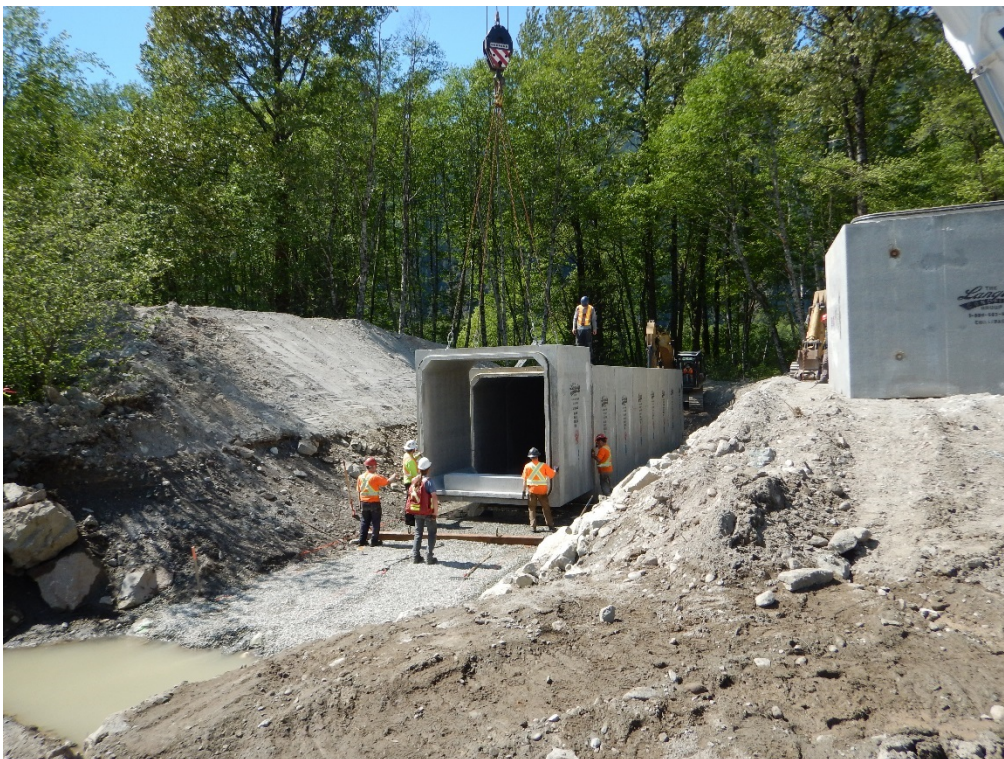
Photo 6. Culvert installation almost complete

The 3m x 3m diameter concrete box culvert design consisted of 11 individual pieces that would make up the 35m length culvert and two headwalls that would be placed at either end. The order for the culvert was placed with Langley Concrete in early February with some modifications around installing baffles. The engineering design for the box culvert took into consideration the KWL flood modelling and concrete baffles were determined to be the best means by which to reduce flood velocities as predicted in the flood model.

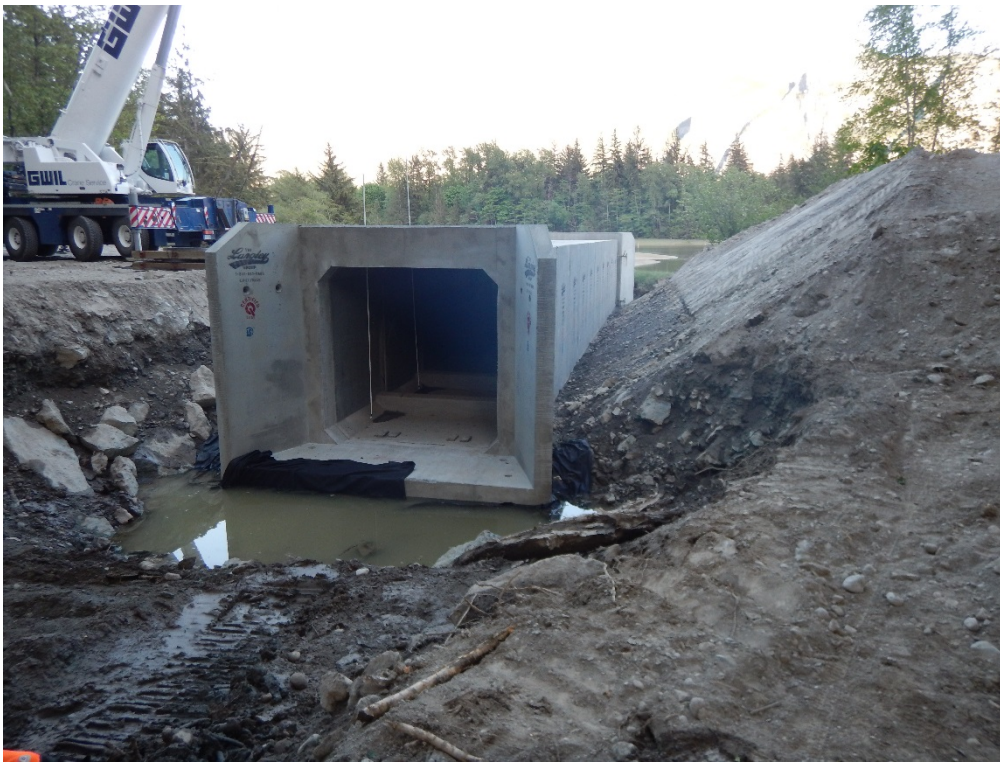
Photo 7. Culvert and headwalls installed (facing east from river side)

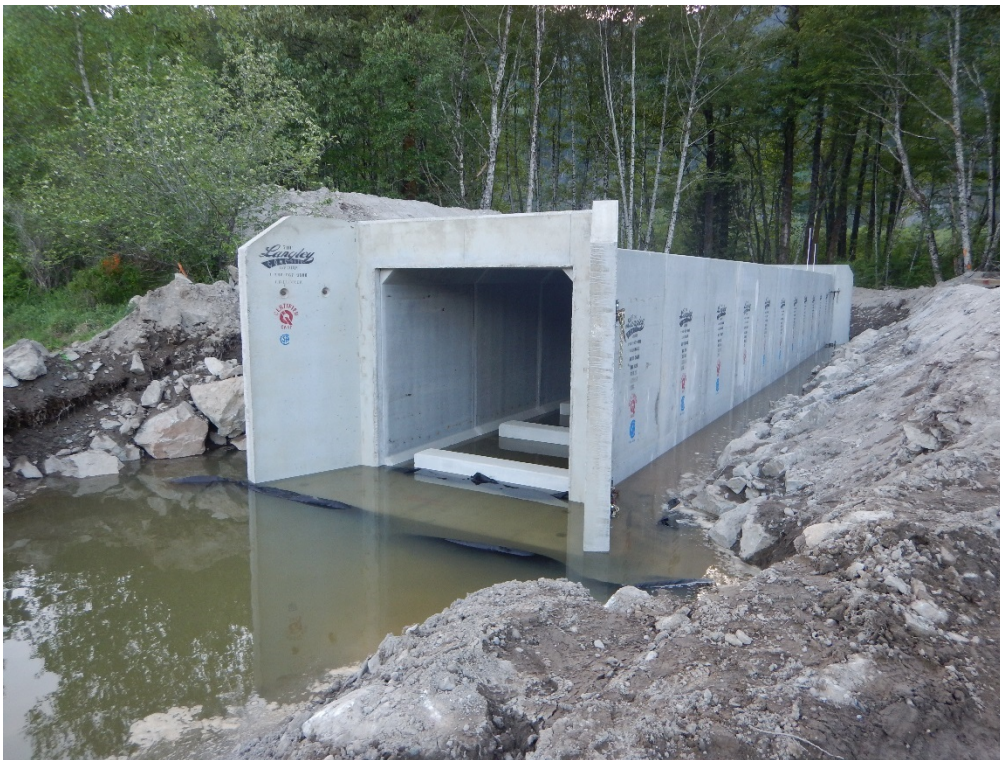
Photo 8. Tide starting to enter from estuary side (facing west)

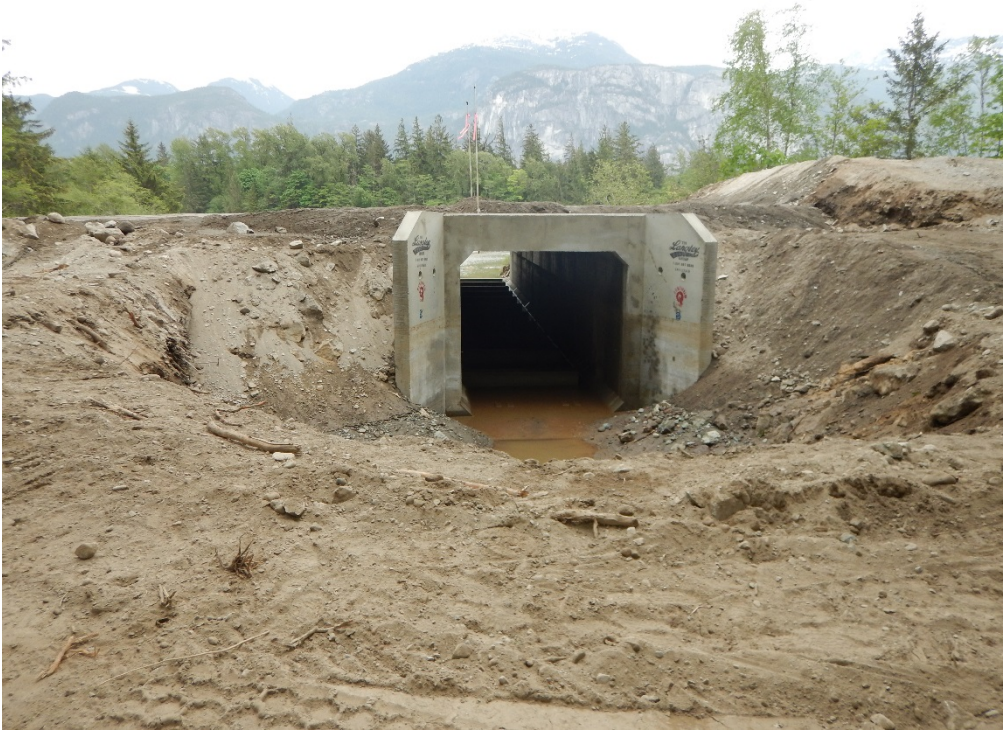
Photo 9. Backfilling over culvert (river side facing east)

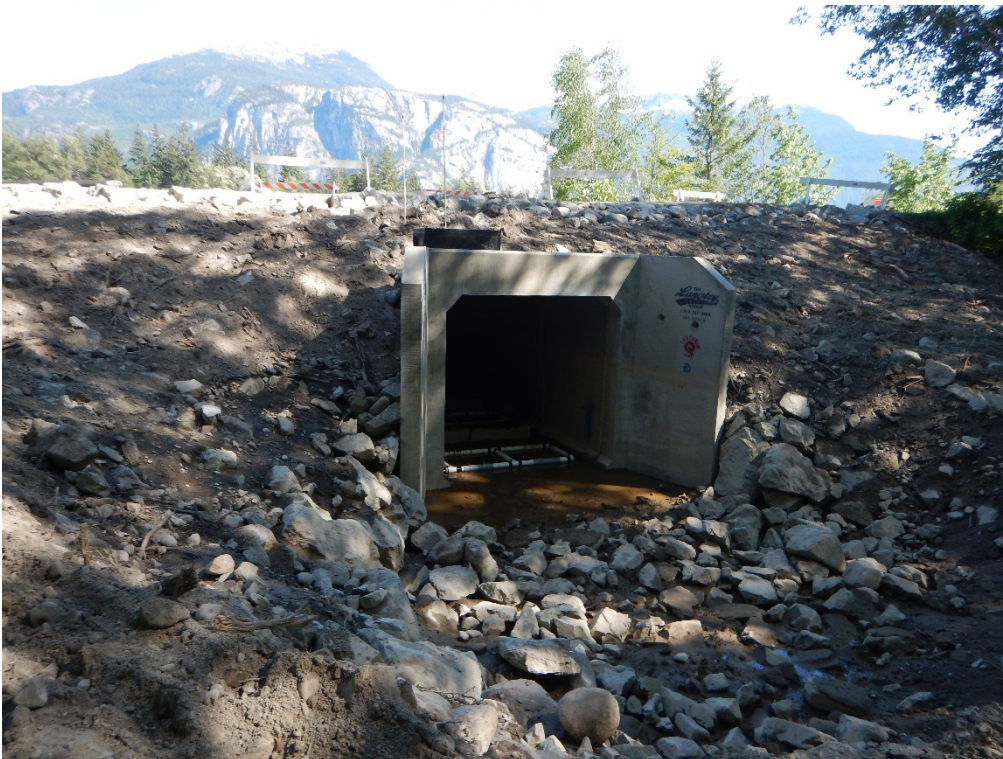
Photo 10. Backfilled and cleaning up site (facing east)
