Central Squamish Estuary Restoration Project

C1-PAC-02 / 17-HPAC-01341-A4 YEAR 4

FINAL REPORT

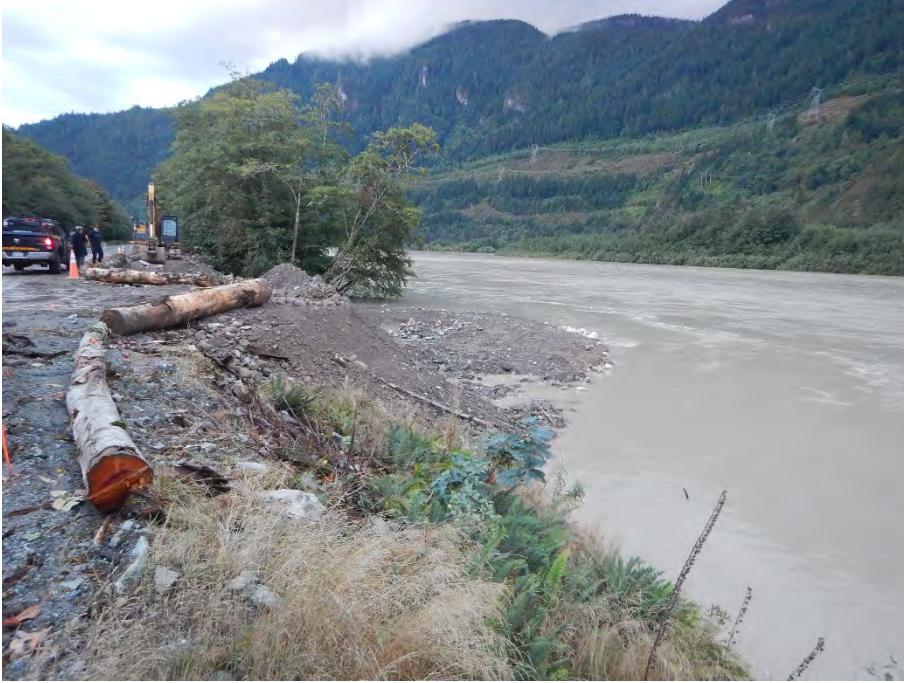
August 21, 2020 high-water event overtopping first coffer dam as it was constructed

As with any project of this magnitude, unexpected issues arise and the construction of Culvert #4 was no different. The original construction of the coffer dams had been designed to a height based on summer freshet flows. However, following a significant storm event in mid-August, the height of the coffer dams was increased by 1 m to prevent overtopping by the river. This proved to be very timely as two more significant and out-of-season storm events occurred during the construction period in September.

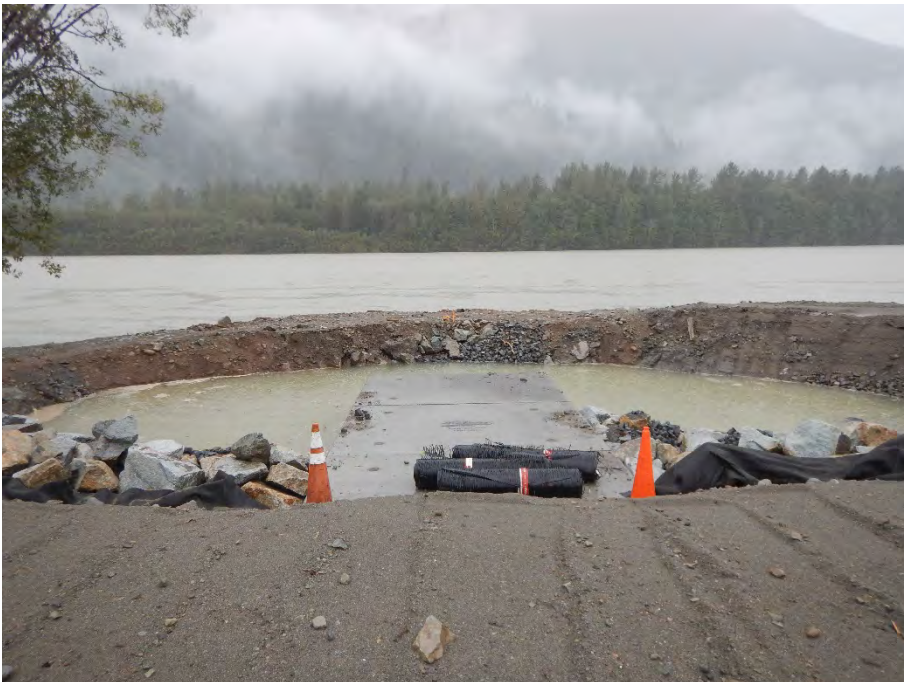
September 23, 2020 reconstructed river coffer dam during large high-water event able to keep out floodwaters

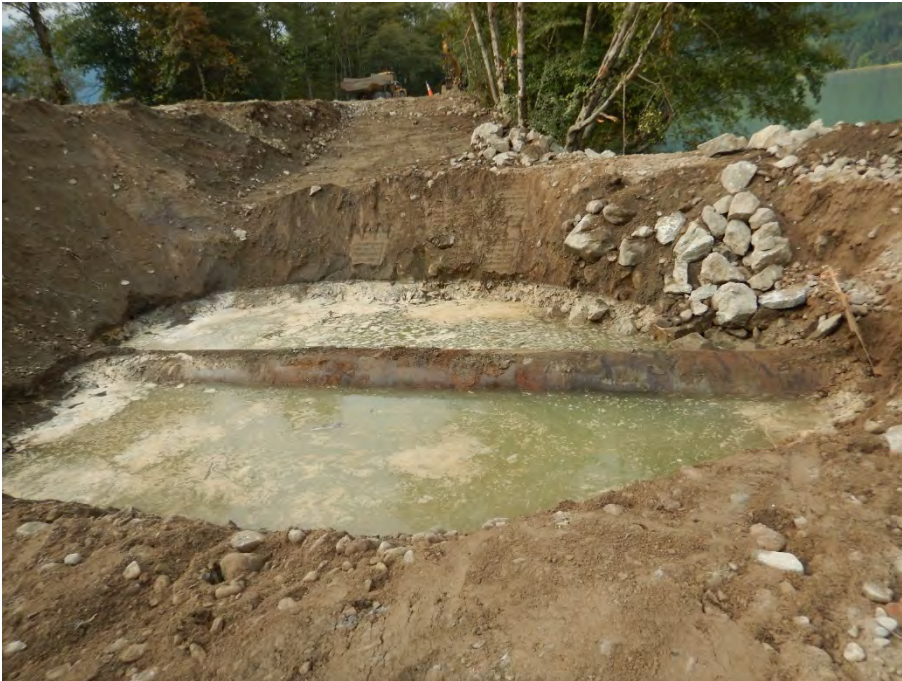
Photo taken September 1 showing the exposed former 1.2 m steel pipe culvert

With the coffer dams in place, the existing culvert was removed, and the excavated material was stockpiled along the berm road. Any excavated material that contained organics was

separated out and was later set aside to end haul to a suitable location off-site. Otherwise, the rest of the excavated material was used as backfill overtop of the new box culvert.

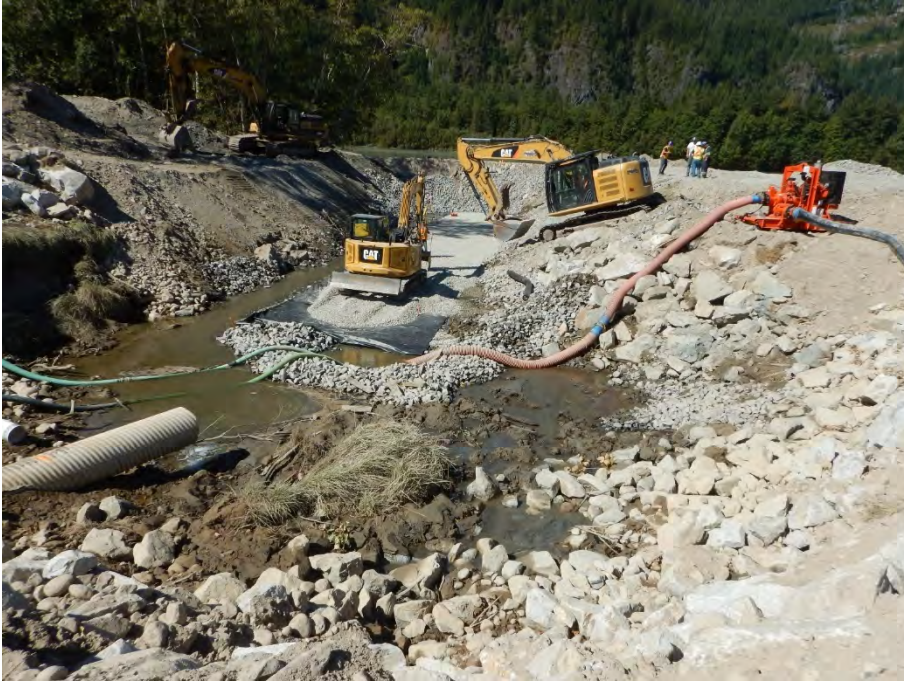
Photo taken September 9, 2020 showing pump in action and drainage channel on left side

Once the site was isolated and the steel pipe culvert removed along with the excess fill material, the site was graded as per the Hydrotechnical Memo and drainage rock and base rock were layered and compacted. The use of a high-power pump that ran 24/7 for the entire duration of the project allowed the site to remain “in the dry”. A drainage channel was constructed along the southern edge to allow water to flow from the river to the estuary side (where the pump was set up) to remove seepage through the river side coffer dam.

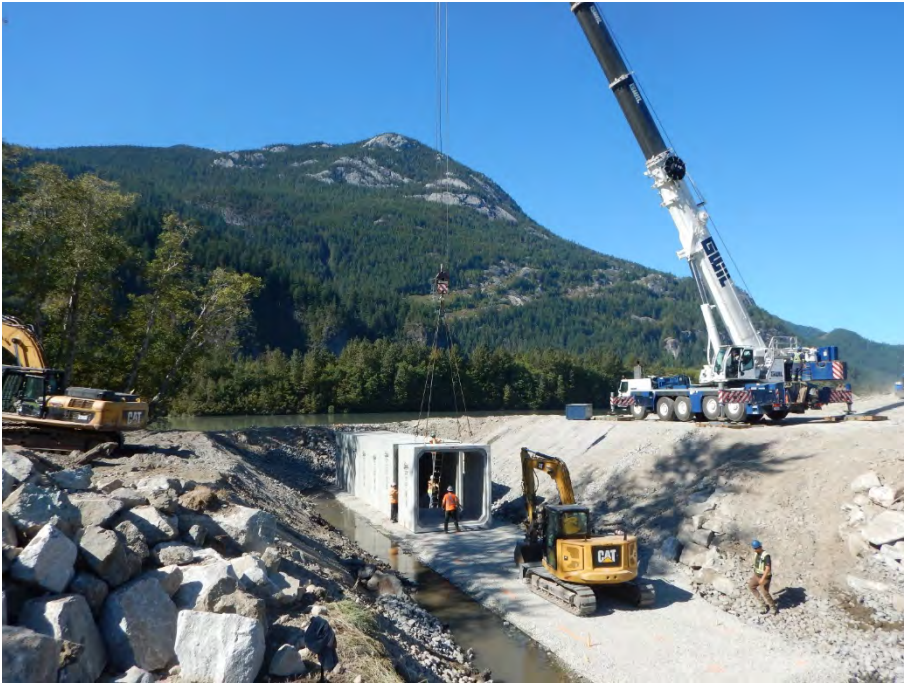
September 10, 2020 culvert segment placement with Gwil 300-t crane

From September 10 to 11 all the culvert pieces were trucked up from Langley Concrete and, with the use of 300 tonne crane, were individually placed from the river side moving east to the estuary side of the site. Each piece was secured in place with the small excavator that would gently “nudge” the culvert segments together until the gaskets were secured into position. Once the culverts segments were positioned over the graded pad work then commenced to back-fill the excavation. As the material was backfilled it was compacted to specifications outlined in the DOS MOU.

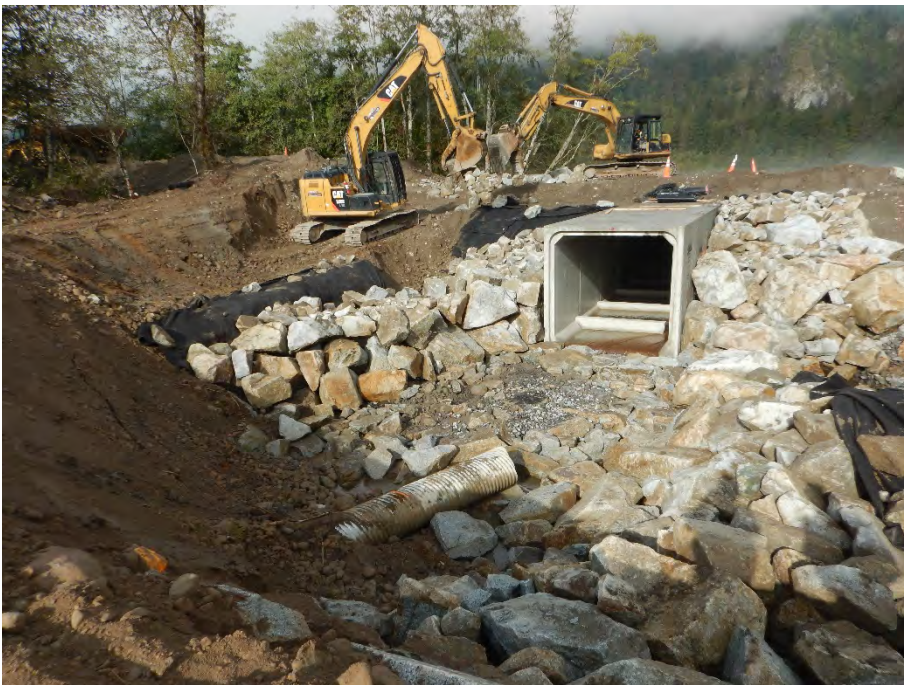
September 22, 2020 backfilling; note geotextile layer below armouring

Geotextile fabric was installed below the armouring material in order to add an extra layer of friction to prevent future slippage of the backfill along the road, slopes, and armouring. The final stages of the project included heavy armouring on the estuary side to prevent scour. As well, the river entranceway was heavily armouring to protect against erosion from large woody debris and large flows.

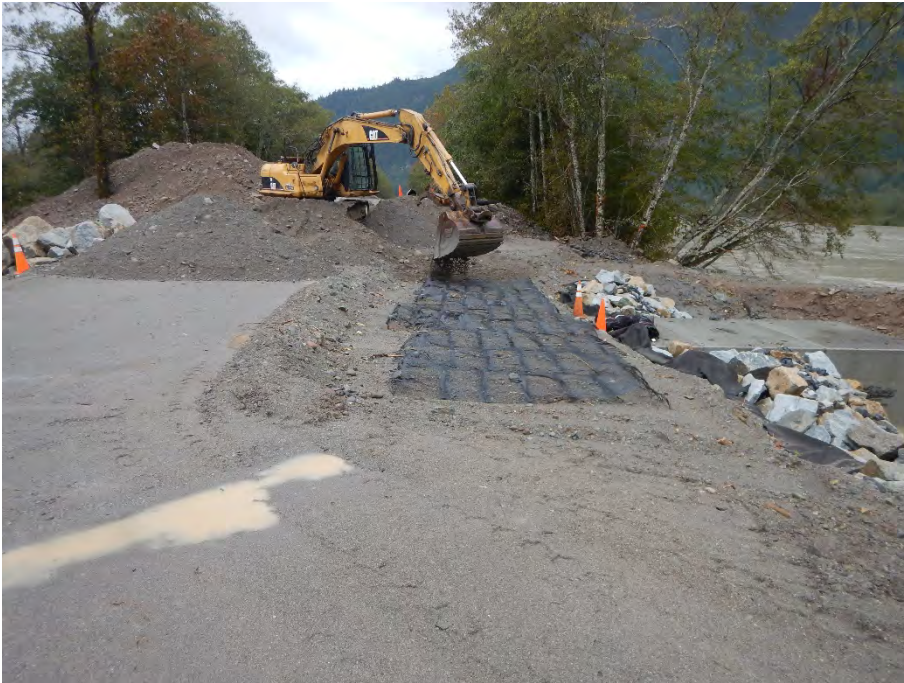
September 24, 2020 placement of geogrid to prevent road slippage

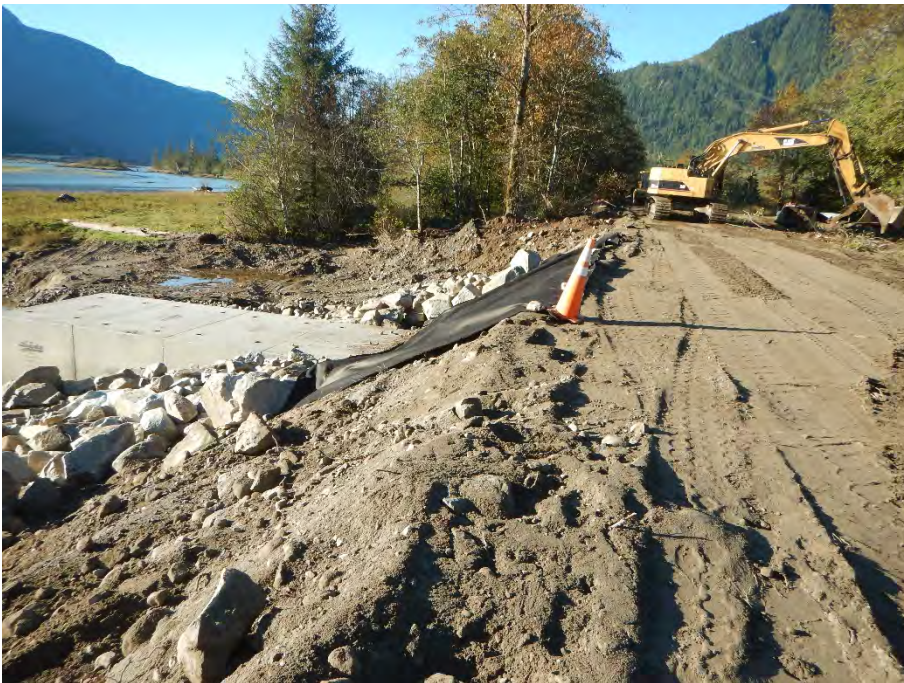
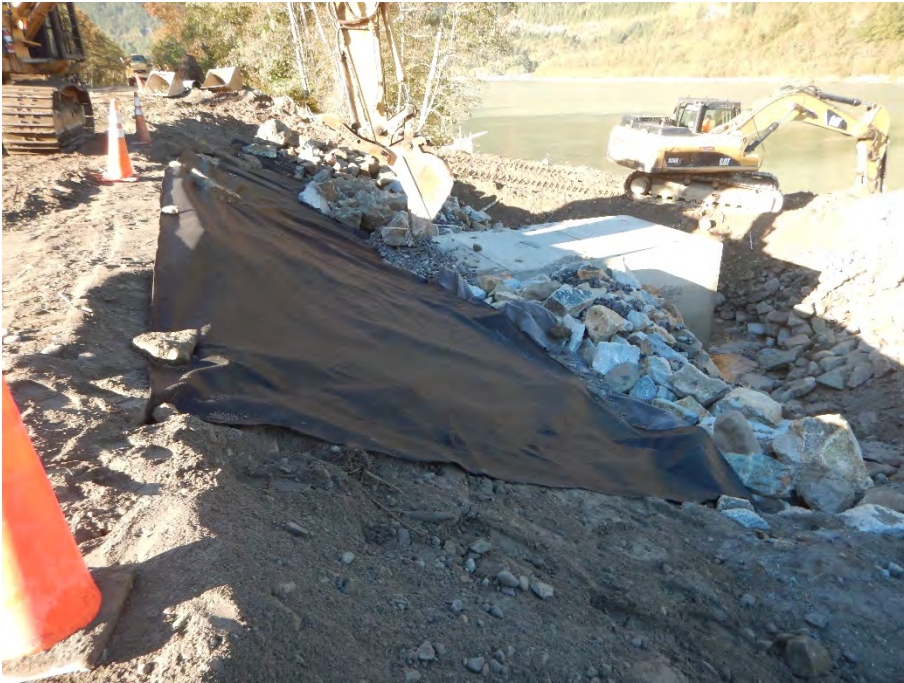
September 29, 2020 geofabric placement on estuary side (above photo) and river side (photo below)

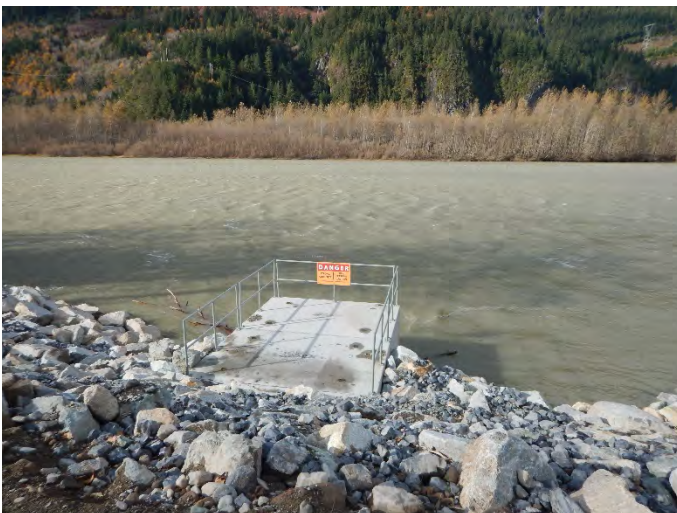
Safety railing and *Signage warning of dangerous currents*

Once the berm road was restored to its original grade, no-post barriers were installed on either side to prevent traffic from driving down either side. As well, railings and danger signage were installed on both sides of the culvert to prevent people from falling over the edge of the culverts.
