Squamish Training Berm Realignment - Wave Impact Assessment

Squamish River Watershed Society

Final Report

Squamish Training Berm Realignment - Wave Impact Assessment		
26 02 2020	663757-1000-4PER-0001_R0.docx	Squamish River Watershed Society

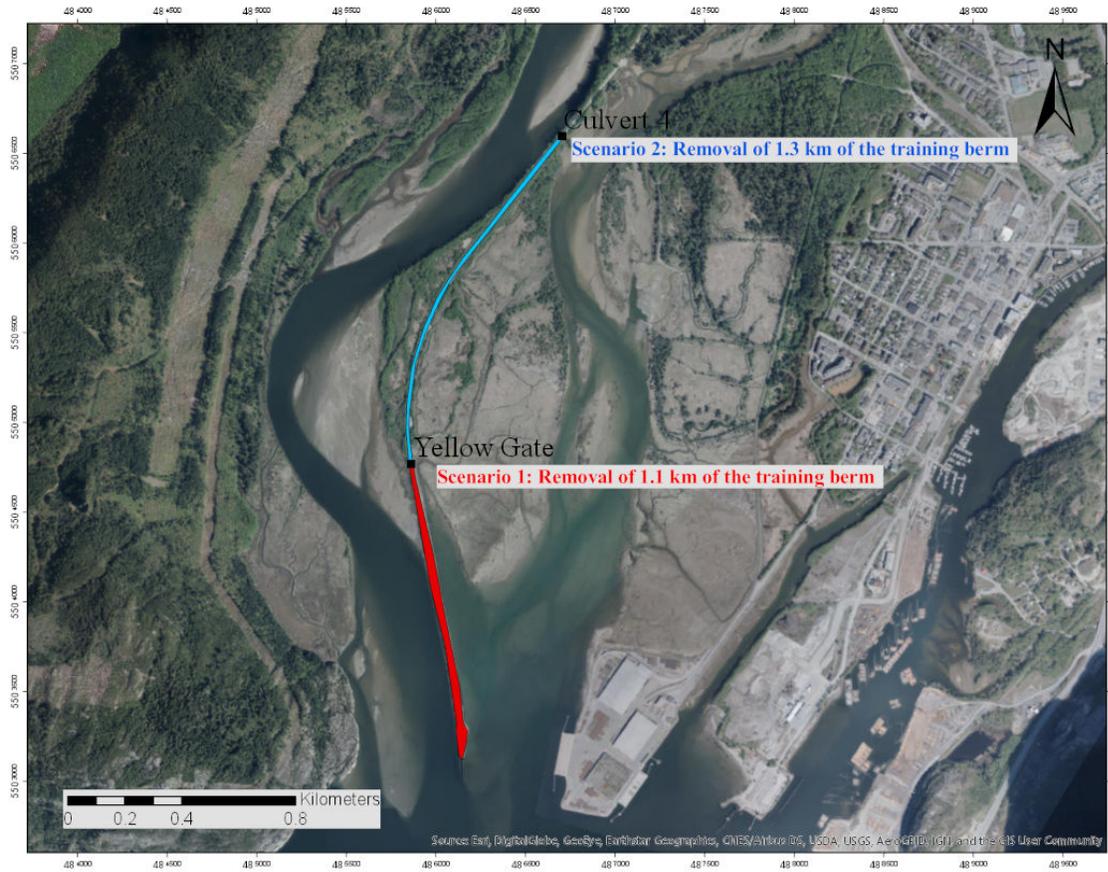
Figure 1 Modelled scenarios

SNC-Lavalin conducted a study in 2015 (Ref [6]), to define the wave climate around the perimeter of the coastal boundary of the District of Squamish (Figure 1) and provided coastal water levels expected to be concurrent with major river flooding events. Also, SNC-Lavalin found that the training berm provides protection against wave effects within Crescent Slough and in particular to the Town Dike.

The objective of the current study is to provide a preliminary assessment of the wave climate impact, before (current conditions – existing training berm) and after the training berm removal, as described for the two scenarios below:

- › Scenario 1: removal of training berm up to the yellow gate (approximately removal length: 1.1 km)
- › Scenario 2: removal of the training berm up to Culvert 4 (approximately additional removal length: 1.3 km)

Scenario 1 consists of removing the training berm up to “the Yellow Gate” (Figure 1), representing the removal of approximately 1.1 km of the berm length. The removal will likely modify the estuary morphology and the bathymetry for this scenario was estimated based on existing information and sediment transport models trends previously developed for the region.

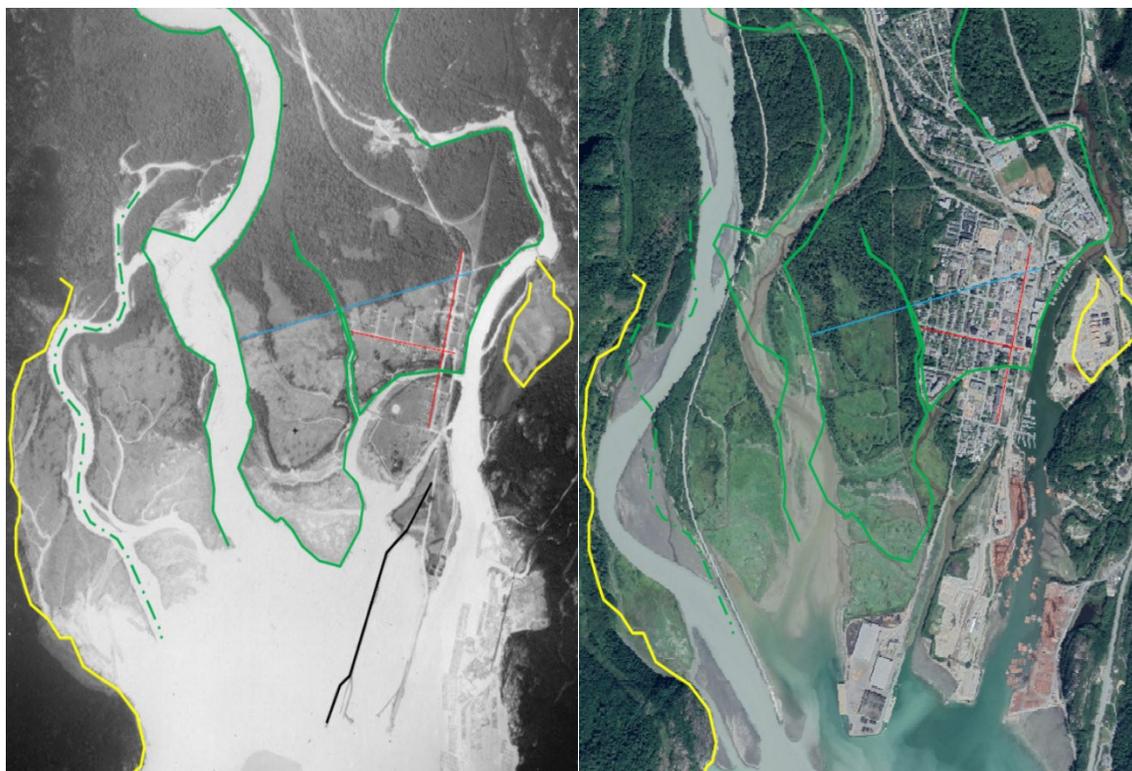
Figure 2 River alignment comparison, 1930 (left) and 2019 (right)

The Squamish River delta shows major change over time, likely due to the construction of the training berm in the 1970s (Figure 2). The river currently flows through its west branch. The thalweg of this branch migrated toward the west over time. The east part of the river in the Central Channel is currently shallower as sedimentation played an important role in the river morphology over the years. Figure 2 shows an approximate comparison of the river alignment between 1930 and 2019.

Historical air photographs suggests that the main channel of the Squamish River will likely migrate eastwards at the south tip of the central Island (Figure 2) once the training berm is removed. Therefore, the bathymetry has been modified to represent the assumed new riverbed. The west bank of the existing river, from elevations higher than -1 m CD remained unchanged. East of the riverbed toward Squamish District depths were also increased to allow the interpolation of a gentle slope up to the eastern side of the central estuary. The bathymetry along the sections of the berm removal were changed to the average depths from east and west side of the berm. The proposed Scenario 1 bathymetry is presented in Figure 6.

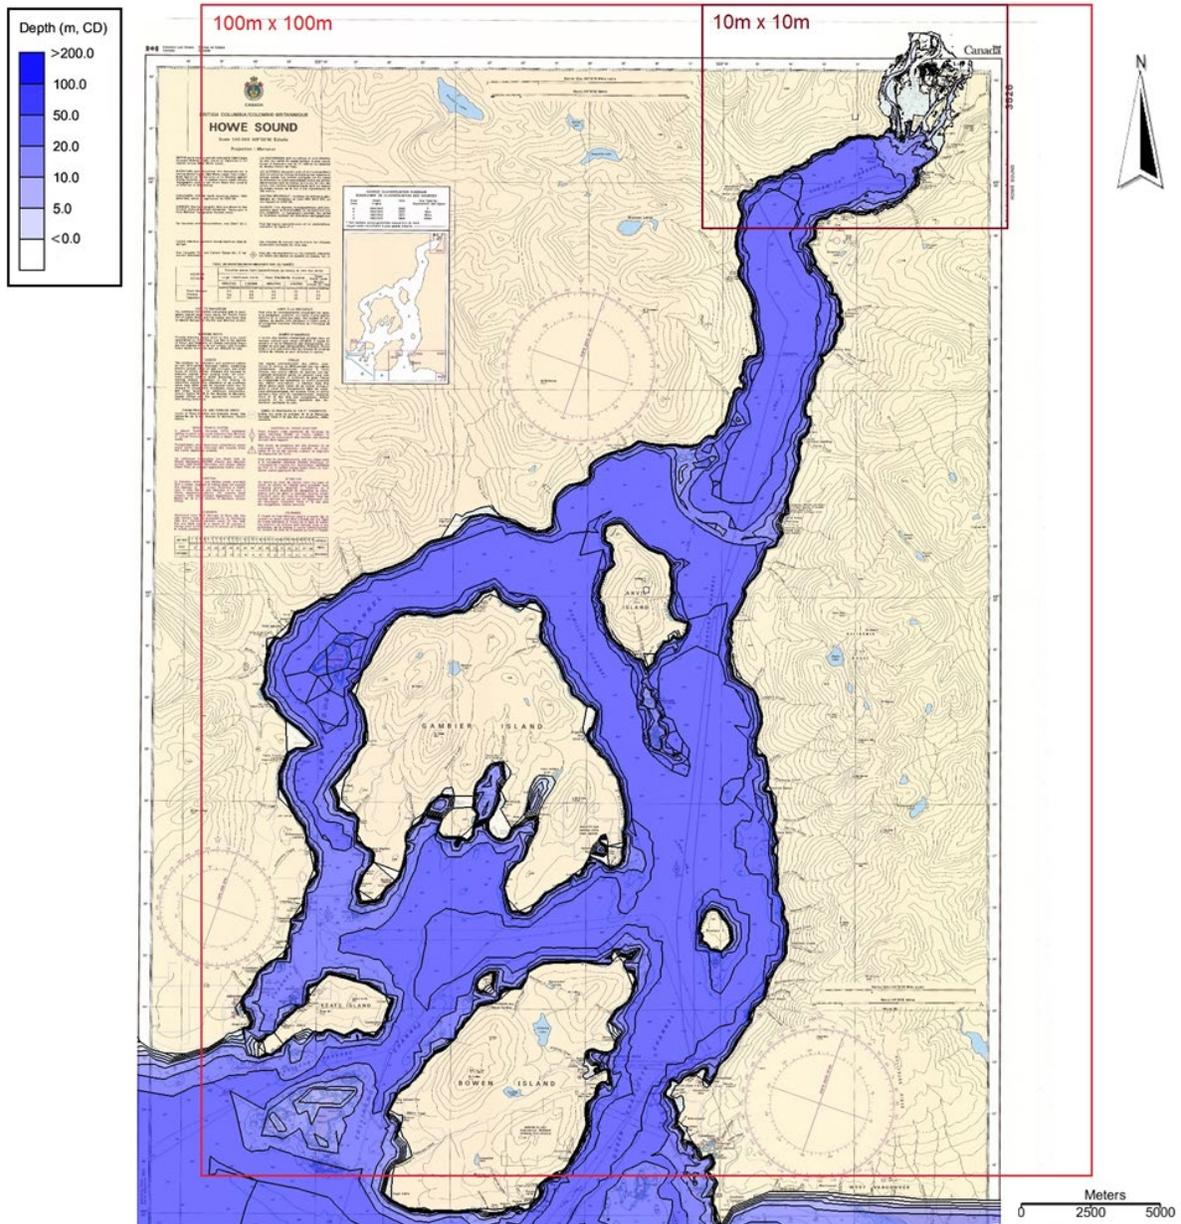
Figure 3 SWAN coarse and nested grid bathymetry used for the wave modelling

The model was developed using nested and coarse grids. The model layout is shown in Figure 3 and a compiled view of the bathymetry ensemble over the Squamish Estuary is shown in Figure 4.

The bathymetry for the coarse (100 m x 100 m) model grid is based on a blend of the CHS digital coastal 500 m x 500 m model for coastal British Columbia and digitized chart-based contours close to the shorelines of Howe Sound and the various islands in the sound. The bathymetry for the fine grid model (10 m x 10 m) is based on a blend of the following data sources:

- CHS digital coastal 500 m x 500 m model for British Columbia coast
- Digitized nautical chart contours close to shoreline
- CHS Field Sheet Data
- Lidar data from the District of Squamish in 2009

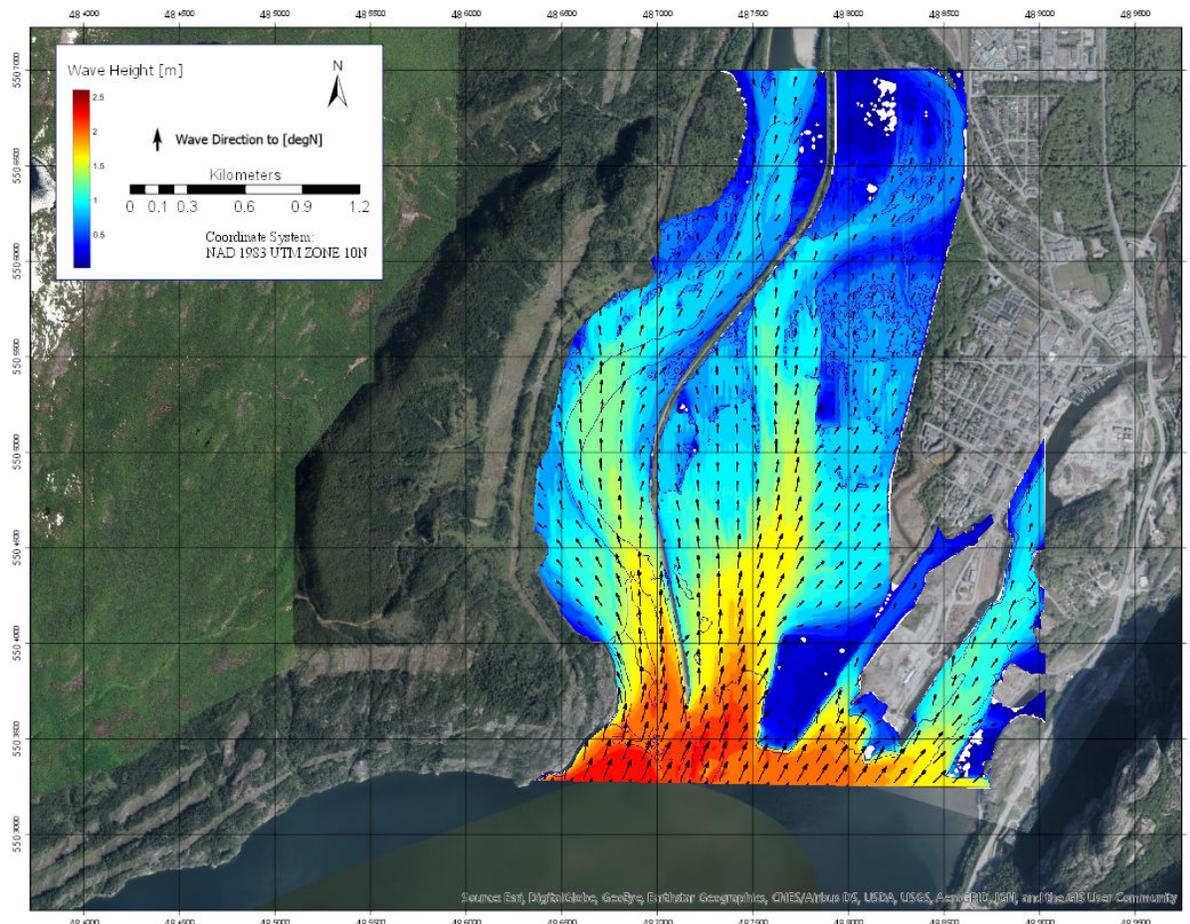
Figure 5: Current conditions wave climate results during 1/200 AEP storm

The wave field results for the current conditions are shown in Figure 5. The results are similar to the “Existing Water Levels” run from Ref.[6]. There is a considerable spatial gradient in the significant wave height in the vicinity of the training berm, although its effects are mostly local due to the incident wave direction. It is observed that there is some direct incident wave energy in the central estuary area between the training berm and the Squamish Terminals berth pocket, which is not diffracted around the berm.

The model included wave breaking; however, overtopping and continuous propagation of the overtopping wave energy in the lee of the berm structure are not included. Diffraction around the berm and vertical piled wall are approximate as are the diffraction effects around the Squamish Terminals embankment fill.

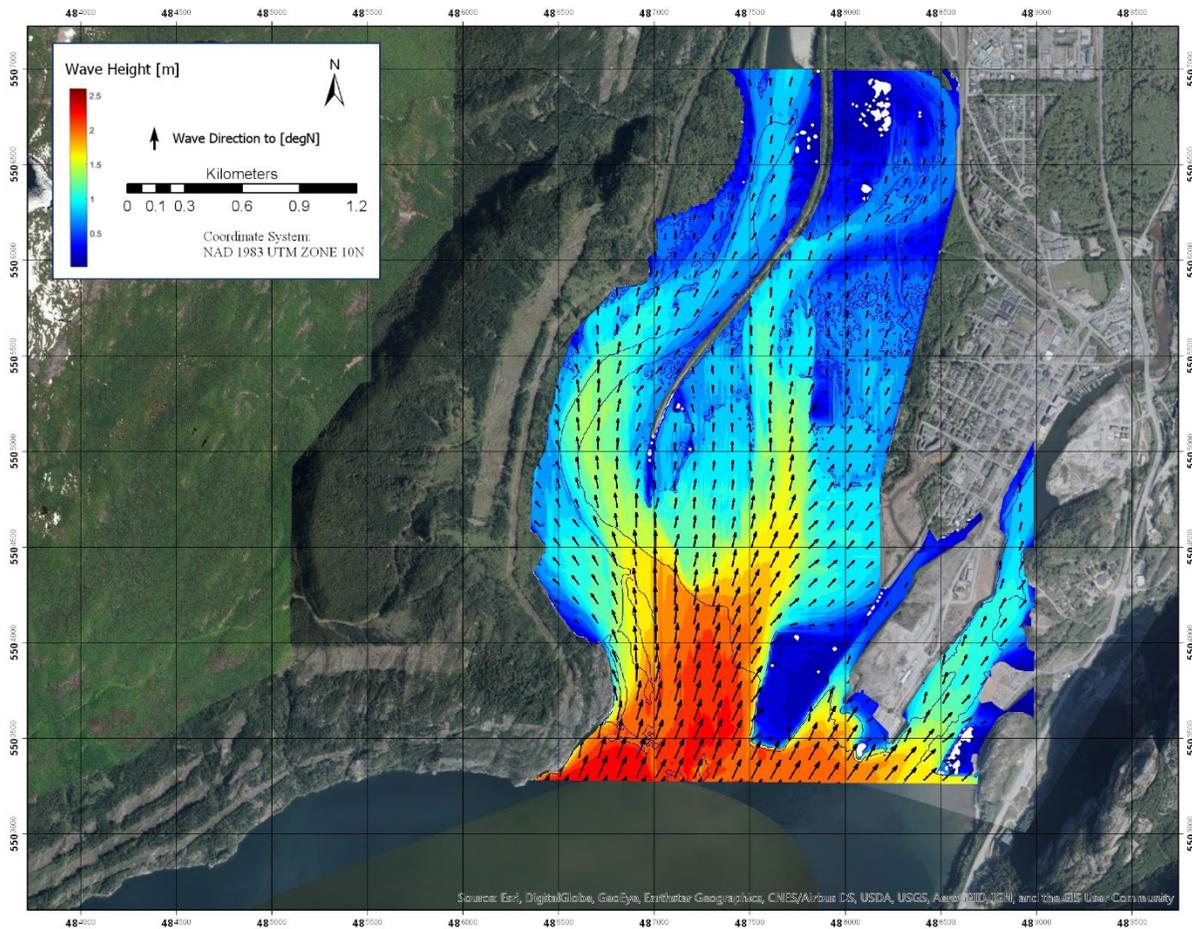
Figure 7: Scenario 1 wave climate results during 1/200 AEP storm

The wave field results are shown in Figure 7 and show that the wave energy is increased, as expected, between the removed section of the berm and the Squamish Terminals berth pocket. The wave climate north of the Terminal is mostly the same as the present conditions with the training berm in place.

Wave heights increase slightly upstream in the river and close to Squamish Terminals, likely because of the assumed morphology changes in the south part of the delta. The wave height increase along the District of Squamish coastal boundary is not significant.

These estimates are only representative of the sea state at the indicated location. Reference should be made to Figure 7 and Figure 9 for information in the likely variation with position in the intermediate area. The same comparison table including the depths for each point and scenario is presented in Appendix B.

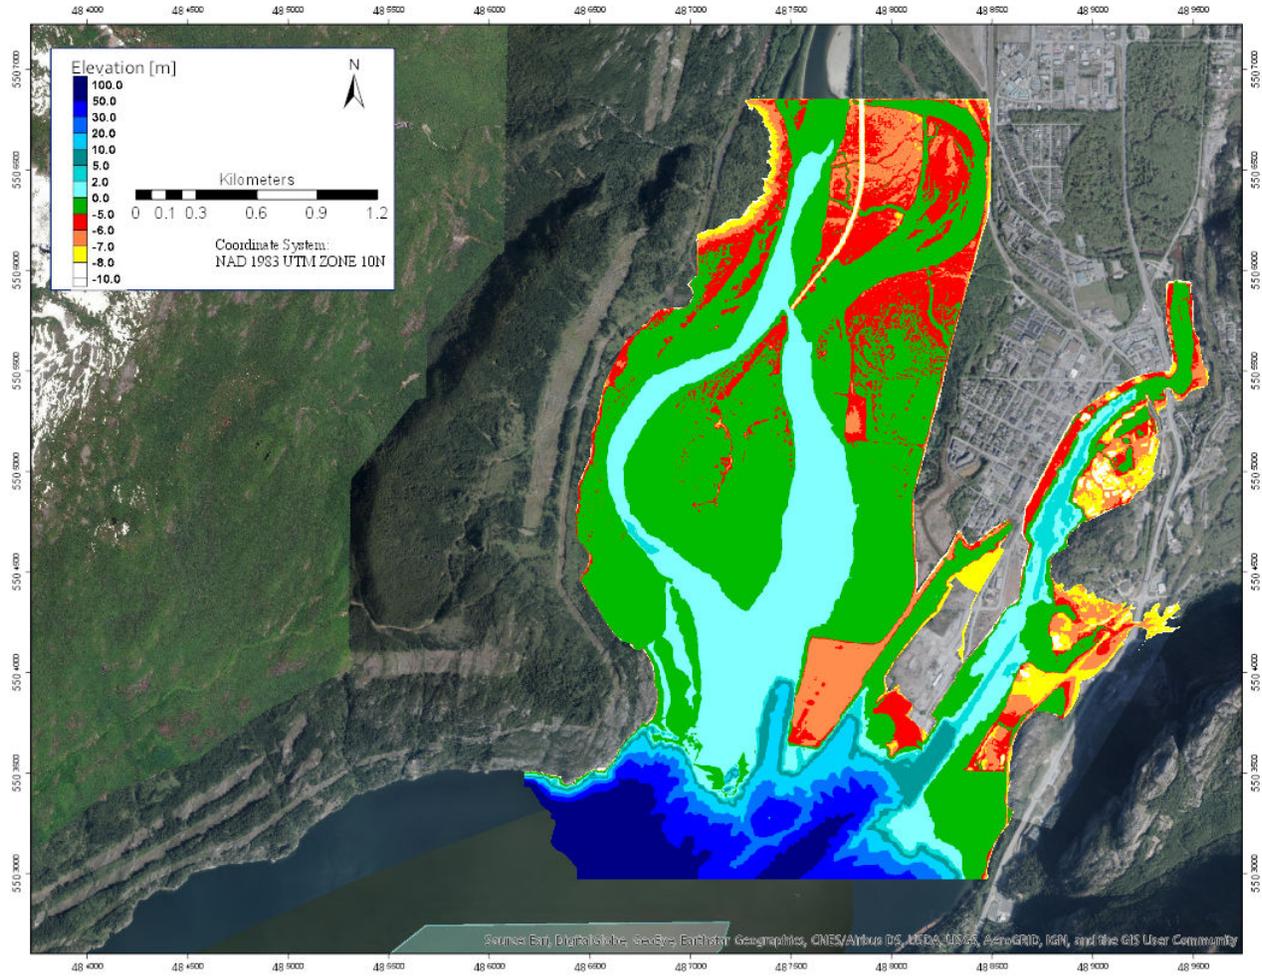
Figure 8: Scenario 2 Bathymetry

As a contingency allowance it was therefore estimated that in the event of an uncontrolled breach at the north end of the central delta, approximately one meter (vertical depth) of sediment could be removed along the low tide banks of the existing Central Slough. The depth of removal would taper to zero at the existing high water line along the existing railway berm. The estimated Scenario 2 bathymetry is shown in Figure 8.

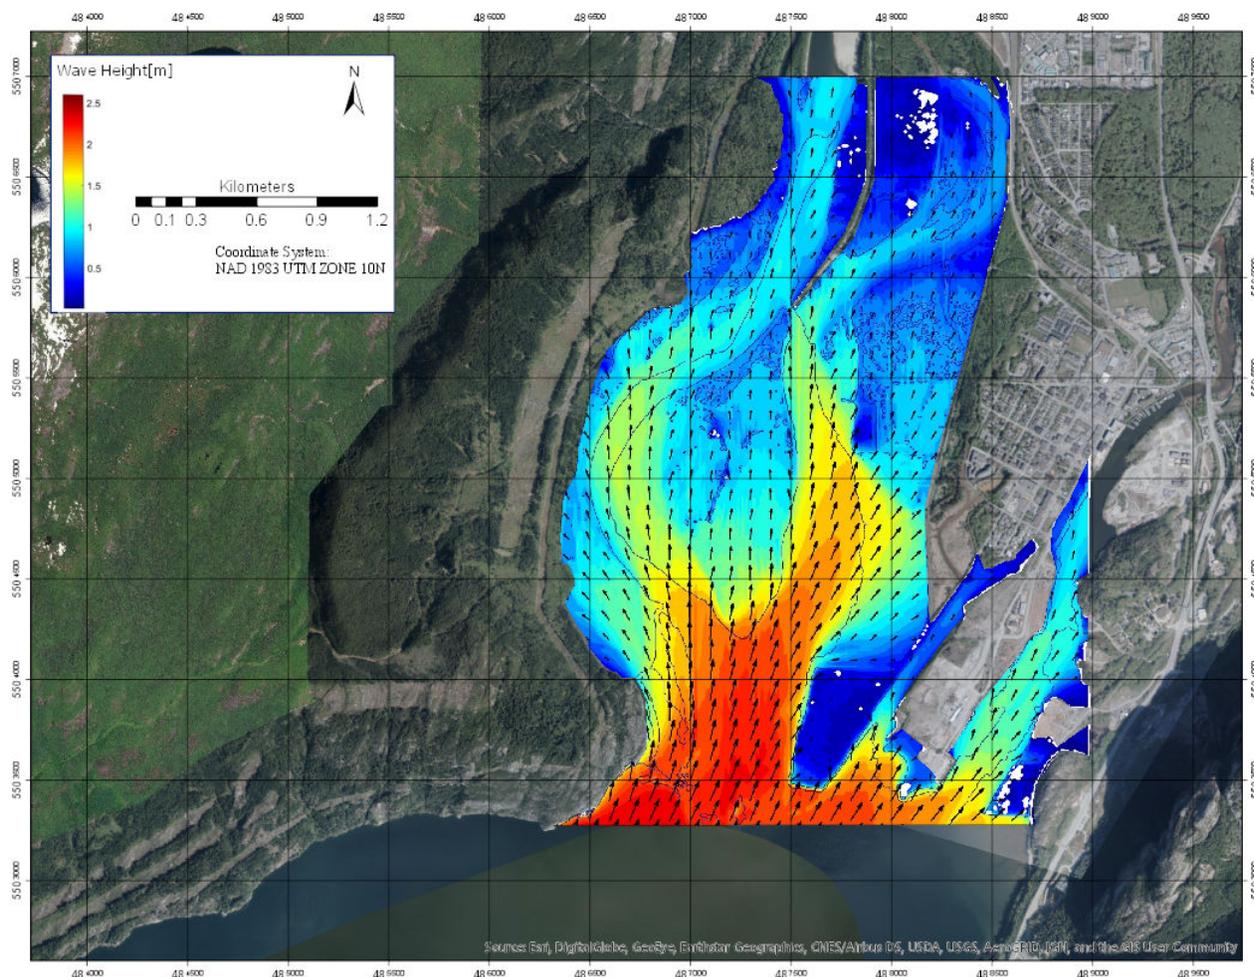
Figure 9: Scenario 2 wave results during 1/200 AEP storm

The wave field resulting from the estimated Scenario 2 bathymetry is presented in Figure 9, which shows that the wave climate will be increased in the Central Channel area and close to the railway embankment.

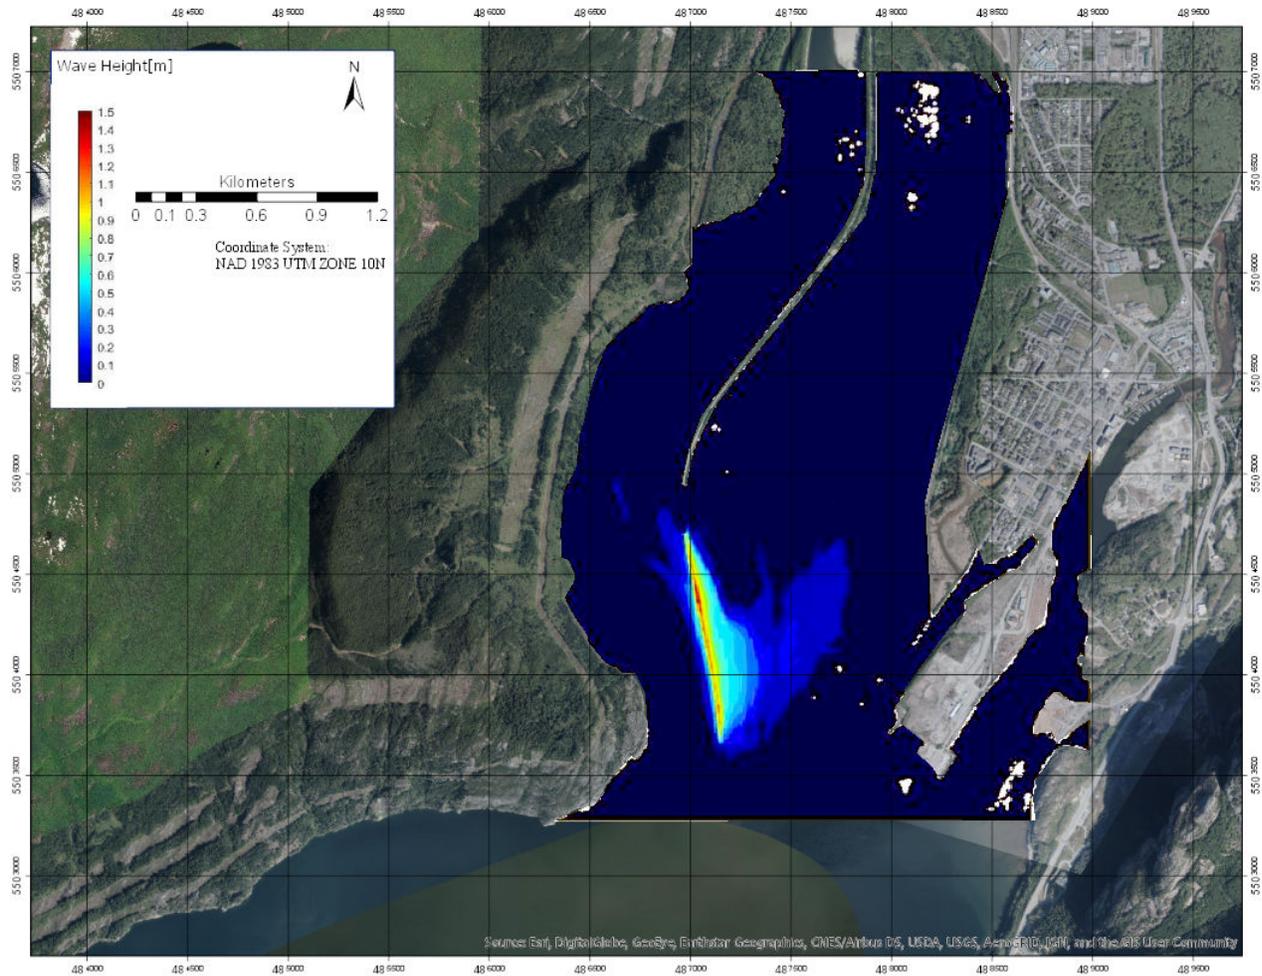
Figure 10: Difference in significant wave height between Scenario 1 and existing conditions during 1/200 AEP storm

Figure 10 shows the difference in modelled significant wave height between Scenario 1 and the present conditions with the training berm in place. Significant difference is identified on the east side of the removed berm, reducing towards the coastline.

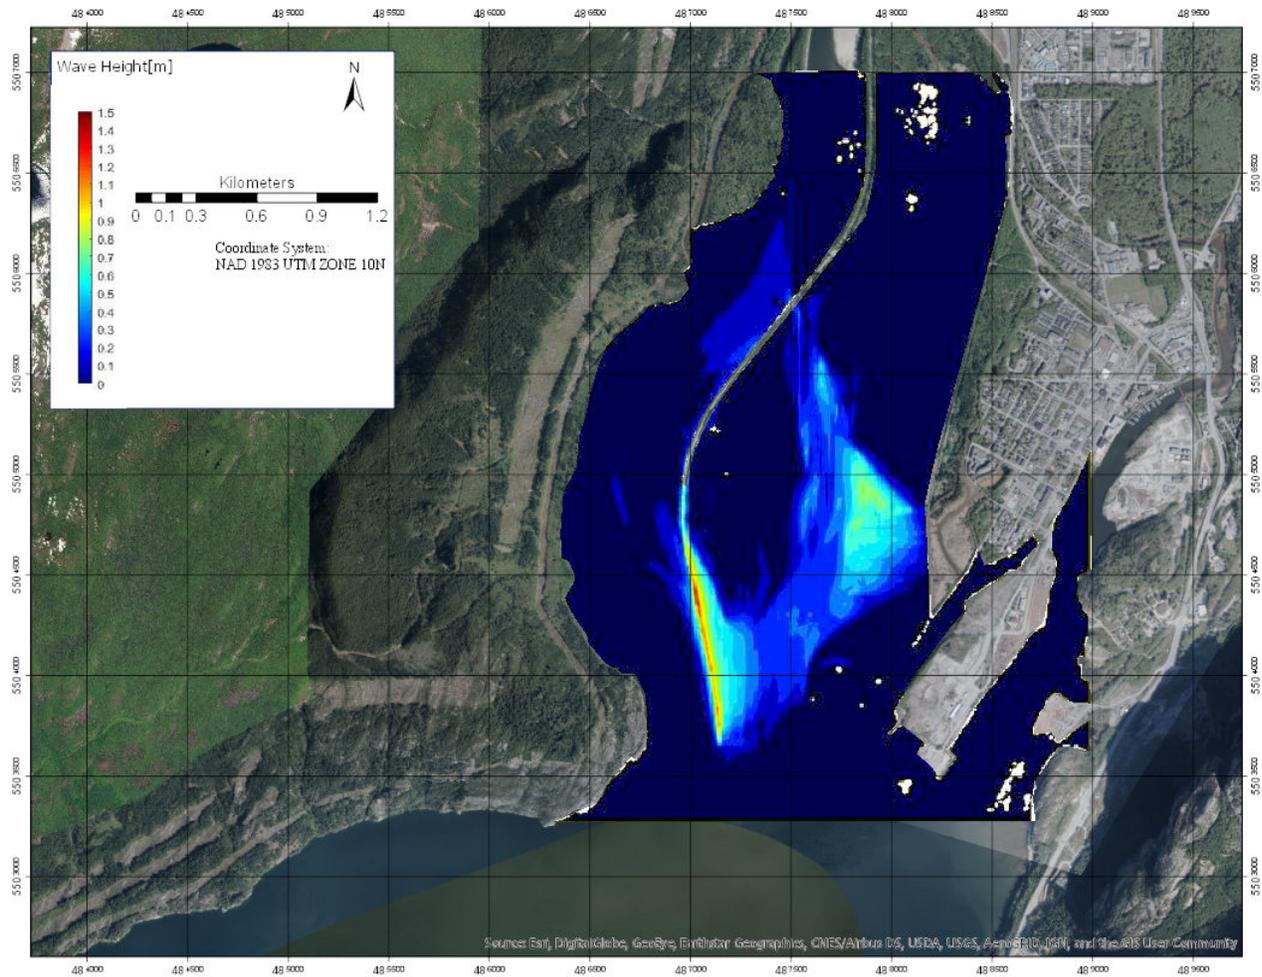
Figure 11: Difference in significant wave height between Scenario 2 and existing conditions during 1/200 AEP storm

Figure 11 shows the differences between Scenario 2 and the existing conditions with the training berm in place.

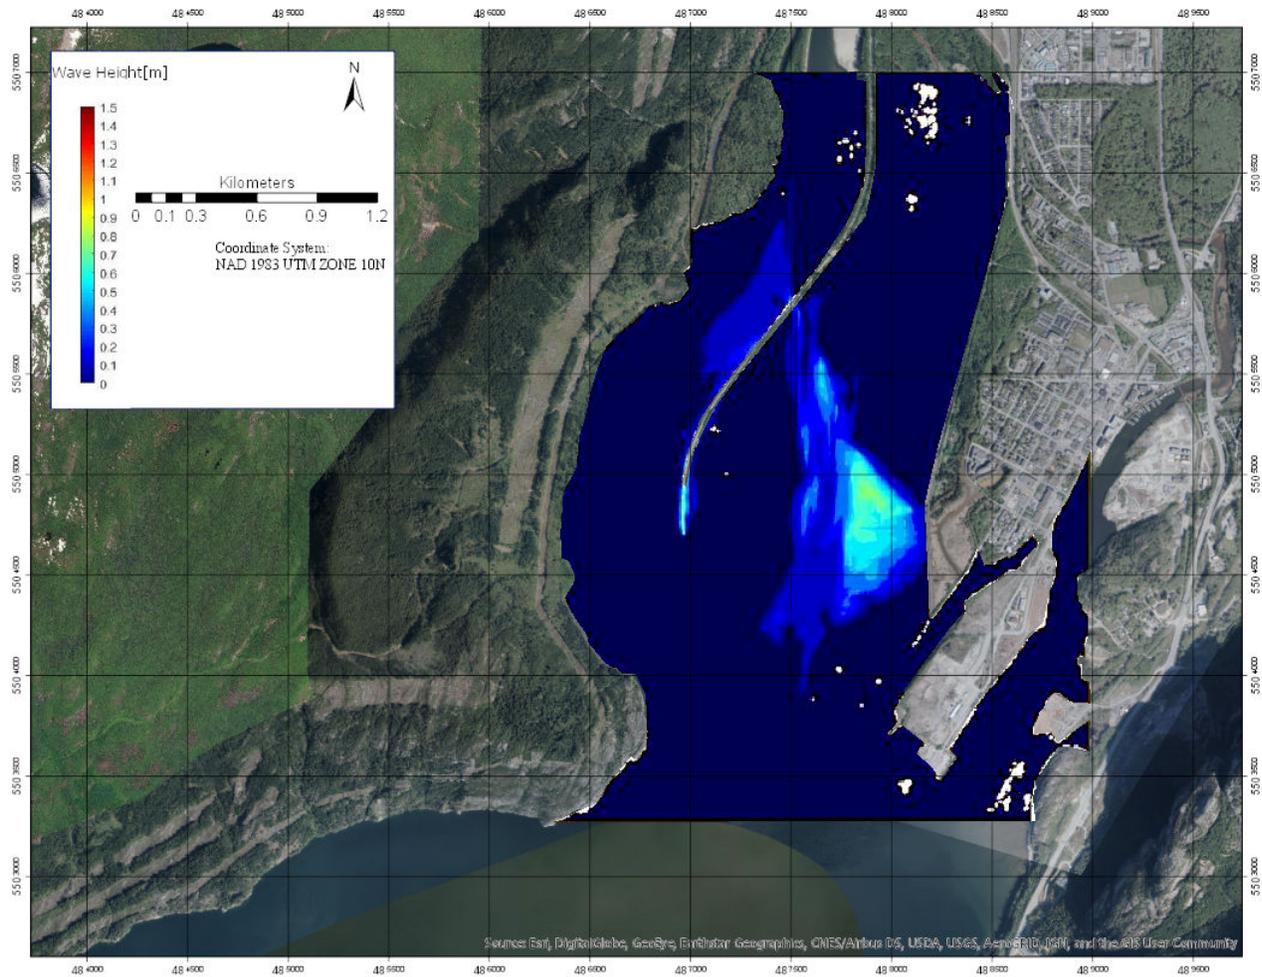
Figure 12: Difference in significant wave height between Scenario 2 and Scenario 1 during 1/200 AEP storm

of the potential increase of the wave climate close to the embankment is relatively small as shown in Figure 12 and likely sensitive to the assumed erosion model expected in the event of an uncontrolled breach in the Culvert 4 area.

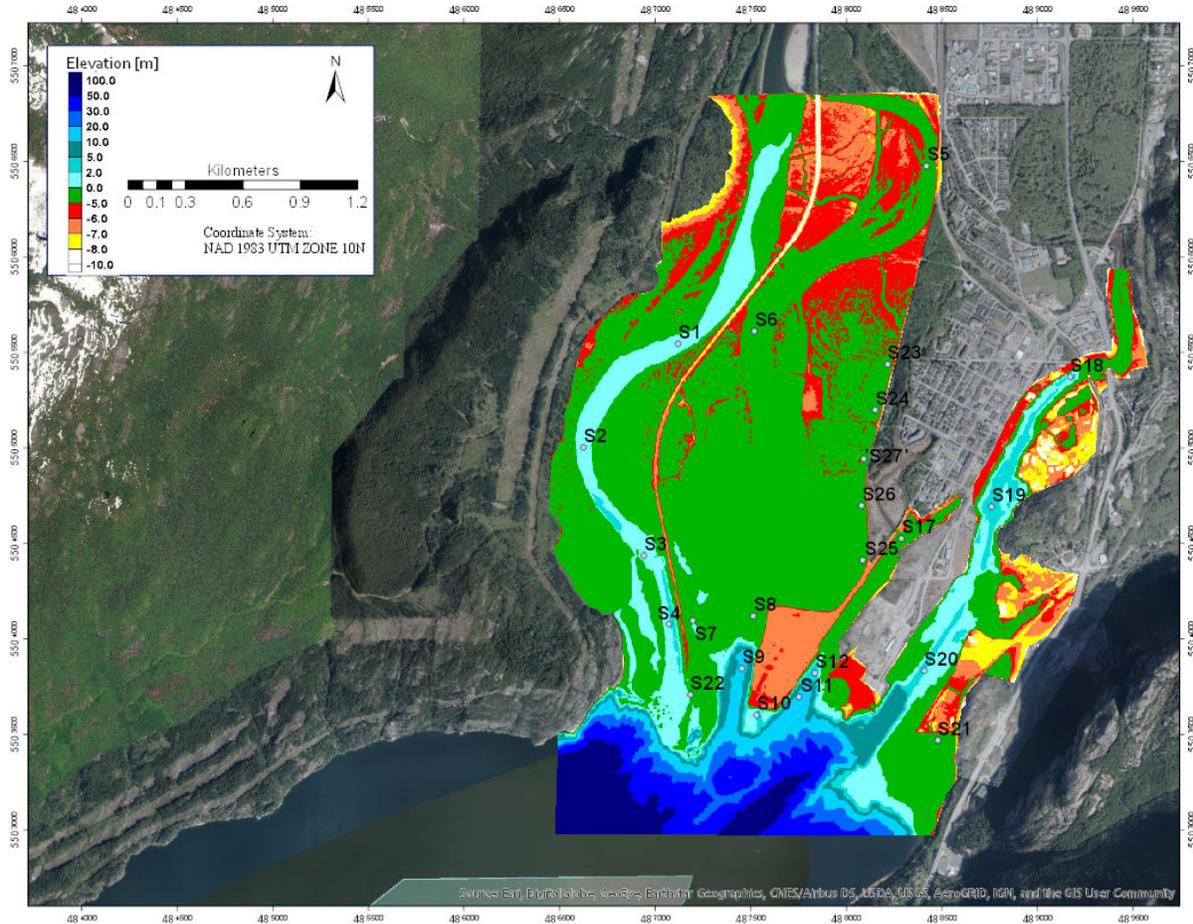
Figure 13: Locations of Site Specific Sea State Results

Increases of significant wave heights are highlighted in red, while points with the same results for the different scenarios are highlighted in green. The locations are the same presented in the 2015 wave assessment (Ref. [6]).

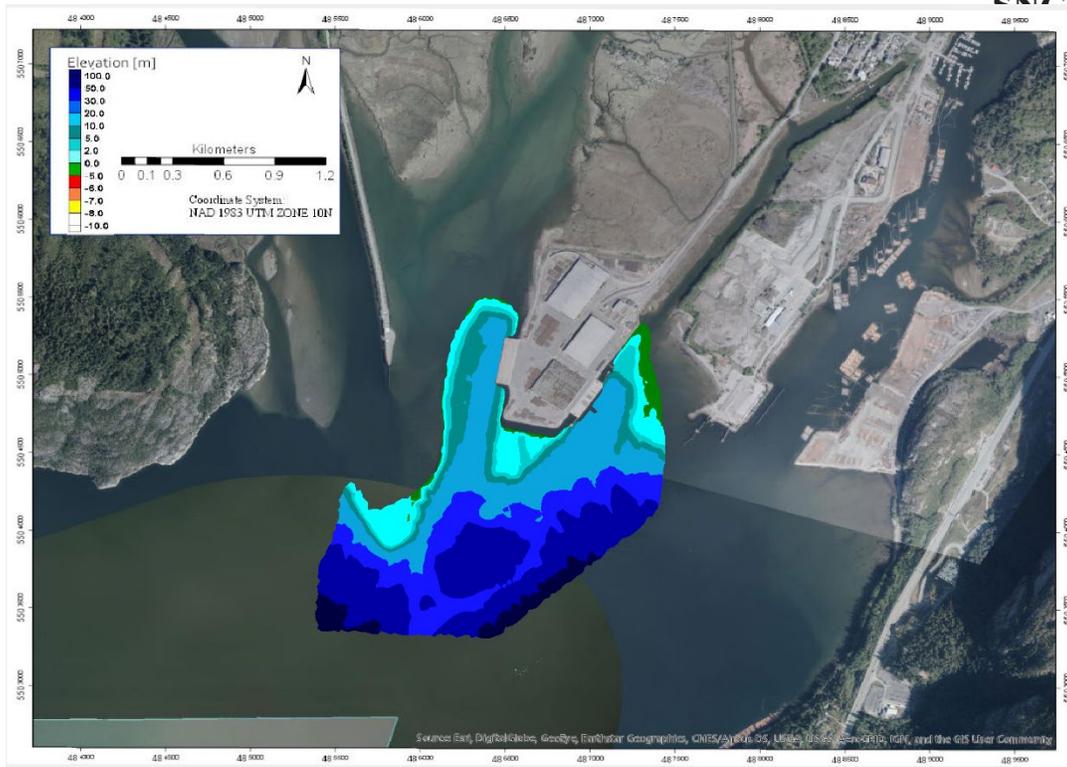
Figure A- 1 Bathymetry dataset provided by Squamish Terminals – 2017 survey

- › Tetra Tech (Ref. [3]) used the combination of 2015 CHS bathymetric survey and 2017 bathymetric survey by the Canadian Coast Guard for the Squamish Harbour Model. Bathymetry data from 2017 was provided by Squamish Terminals and it is shown in Figure A- 1
- › The most recent data from a 2019 survey (CCOM: Center for Coastal and Ocean Mapping) covers the river and the delta. The data was provided by John Hughes Clarke and it is shown in Figure A- 2. Preliminary comparison with the 2015 data set indicates that:
 - a landslide might have happened at the edge of the delta
 - the river alignment has continued its slight migration west.

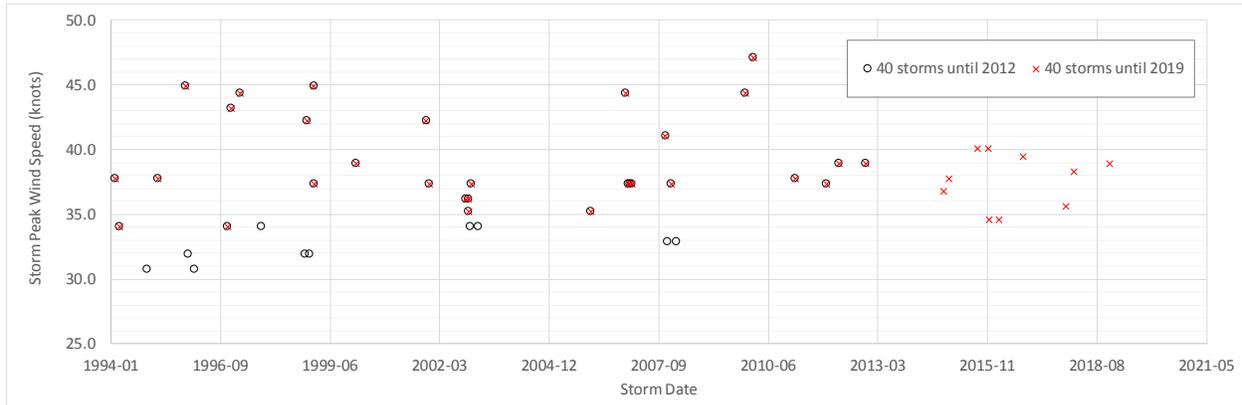
Figure A- 3 Storm comparison 1994-2012 and 2012-2019

Wind data from Pam Rock Station was updated to include information from 2012 to 2019. Figure A- 3 shows the top 40 wind storm events from 1994 to 2012 (Ref. [6]) and 2012 to 2019. It is observed that the recent wind storm are in the middle range of the previously considered storms for the 2015 model study. The current comparison assessment was carried on with the same wind speed and direction from the prior model.

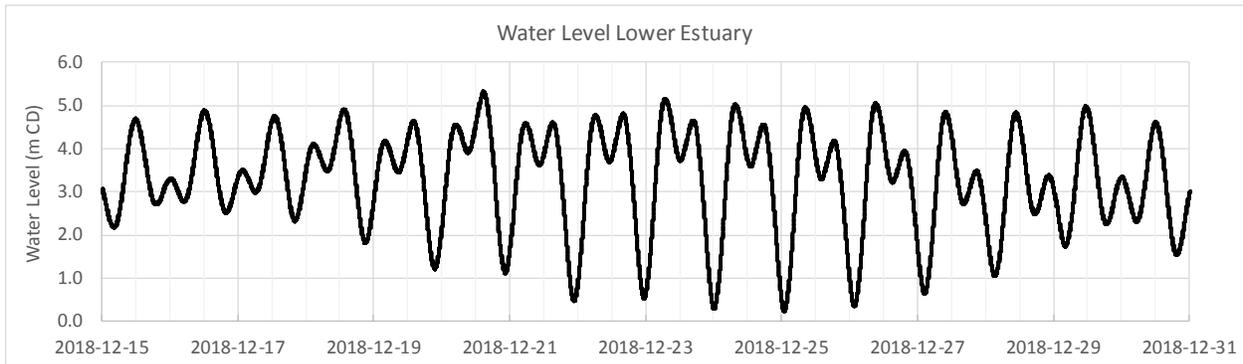
Figure A- 4 Sample of water level measured by SRWS at the lower estuary station

Measured data – SRWS has been measuring water level data at two locations since May 2018. The stations are located at Culvert 4 and lower estuary. Figure A- 4 shows a sample of the measured data at the Lower Estuary Station for the second half of December 2018.

Preliminary comparison with Point Atkinson Station measurements shows residuals over 0.4 m. It is recommended a deeper analysis of the water level and comparisons to wind data to identify storms and reliability of the measurements. The comparison will also check the value assumed in Ref.[6] for external storm surge.
